Some corrections that may significantly improve the already very famous TS-940S receiving performance.

Dedicated to the Detailists

Two errors that I found, both also showed in the Service Manual, Revised Edition.

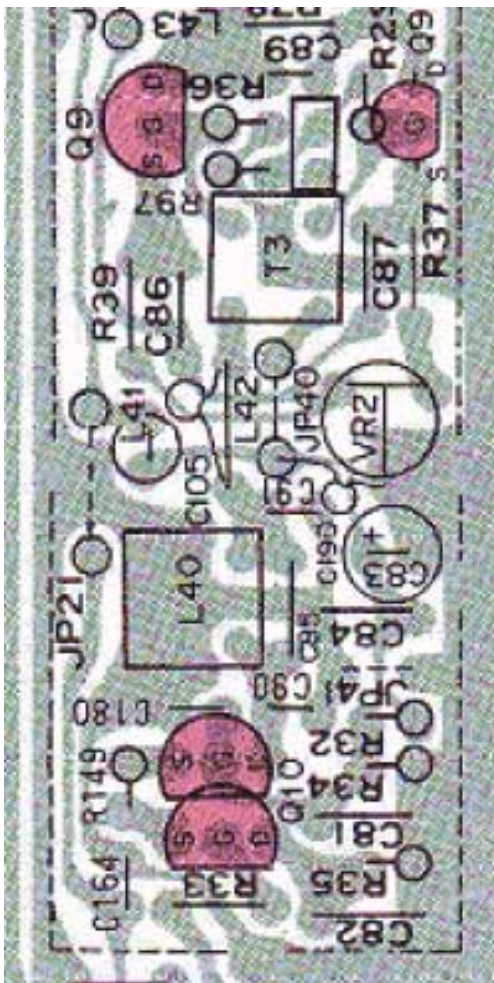
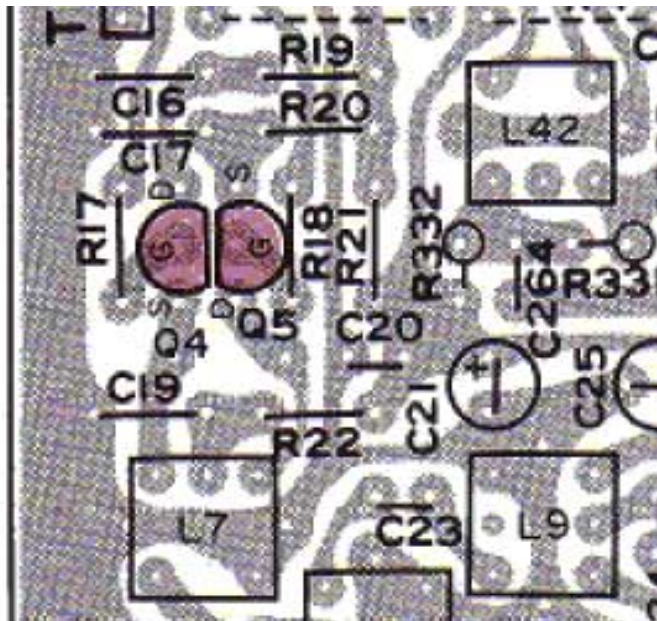
See the FETs Q10 (RF Preamp RF Preamp 2SK125, N-FET, 25V, 0.1A, 0.3W) and Q4 Q5 (2nd balanced mixer, also 2SK125).

The picture above was scanned from the TS-940S Service Manual, Revised Edition. In these pictures the FETs are in the wrong position.

My radio was working apparently well. This is the 1st TS-940S that I could observe and analyze in detail its circuits. First I found the RF Preamp FET in a odd position, but only few days after I could focus and see that the cascode circuit was correct in the schematic diagram and wrong in the PC board. It was also wrong in the PC board view pictures in the Service Manual.

I also noticed that a FET was hotter than the other. It was as simple as de-soldered and turn the FET 180° and re-solder it all over again.

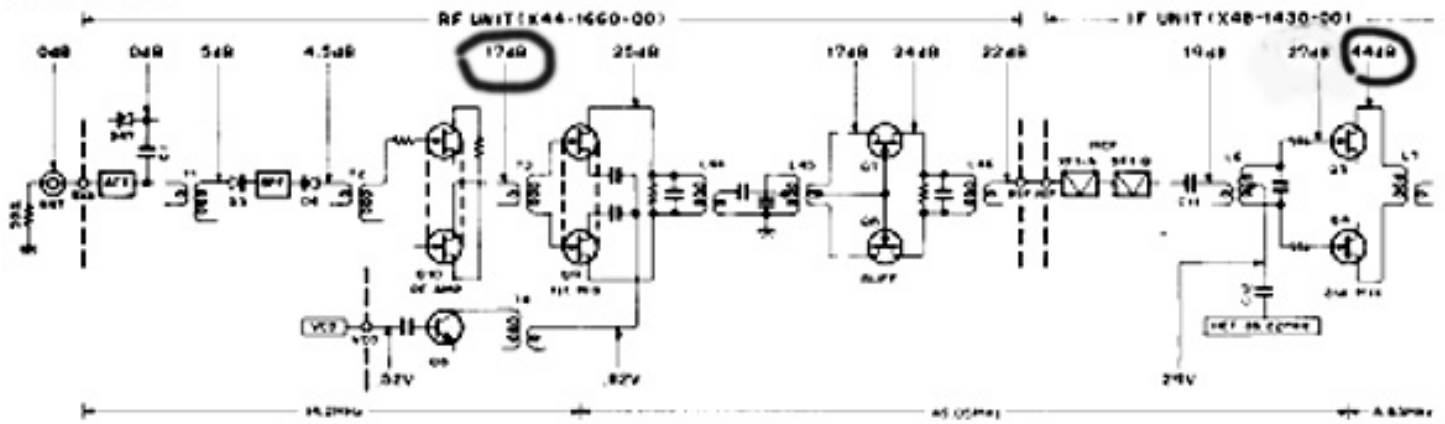
RX SECTION

See the Level Diagram in the Service Manual. With the FETs on the right position, we would have 12.5 dB (17 - 4.5) gain in the RF Preamp, and 17 dB (44 - 27) in the 2nd balanced mixer at the indicated points in the picture above. These gain values are related to the 0 dB input. It would be interesting to measure these gains before the correction. With this measurement we would have an idea about the sensitivity losses due to the two errors.
